Mission Gorge Road Property Demolition

Cultural and Historical Resource Assessment for the Mission Gorge Property Demolition

Prepared by ASM Affiliates, Inc.

March 13, 2009

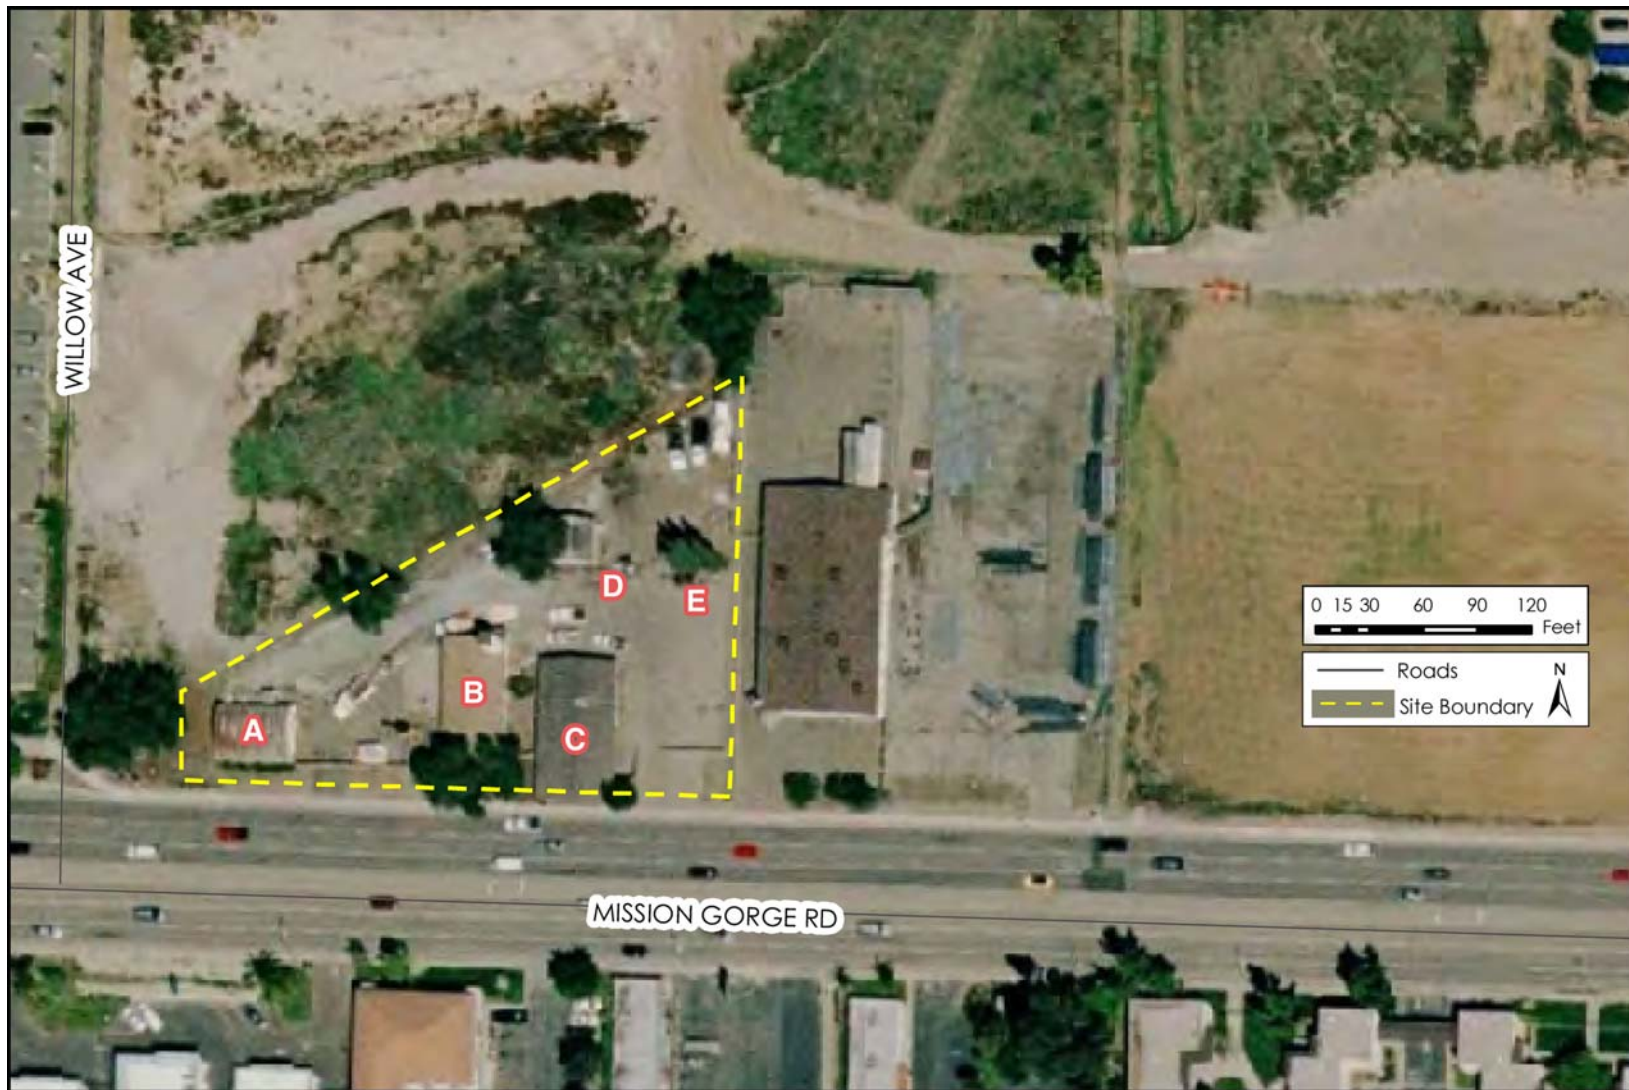
Five buildings are located on the project site. The building assessment was completed by historian and archaeologist Mr. Steven Van Wormer, M.A. Mr. Van Wormer conducted a site visit to document the buildings and assess their integrity. Mr. Van Wormer also performed a cultural resource survey of the property. Each of the buildings is described below. The location of each building is shown on an aerial photograph (see Figure 2).

Figure 2 Aerial view showing the buildings slated for demolition

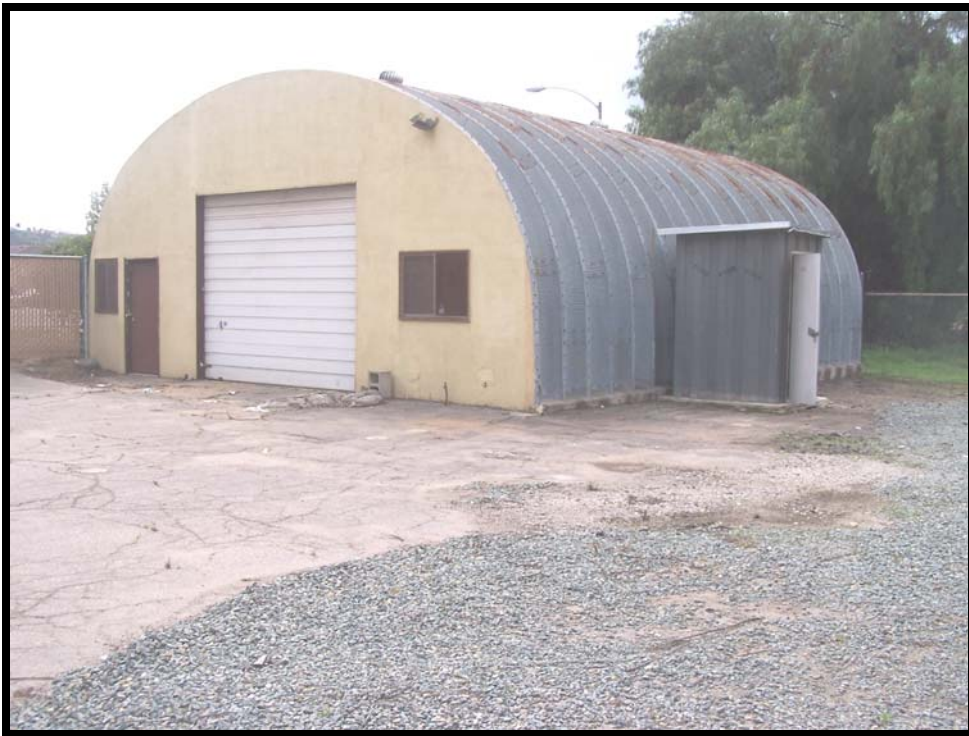
This is a single story, arched “Quonset Hut” style sheet metal building erected on a concrete slab (Figure 3). It appears to have functioned as a garage. The corrugations of the sheet metal shell are much wider and deeper than on Quonset Huts erected during World War II, indicating this building is from the post war era. The east and west ends have been framed in and covered with stucco. Metal roll up garage doors are centered on each end. Aluminum framed sliding windows are located on each side of the doors. A small, square sheet metal shed is mounted on a concrete slab on the north side of the building. A date in the concrete reads '89, suggesting that it was erected in 1989.

Figure 3 Quonset Hut (Building A)

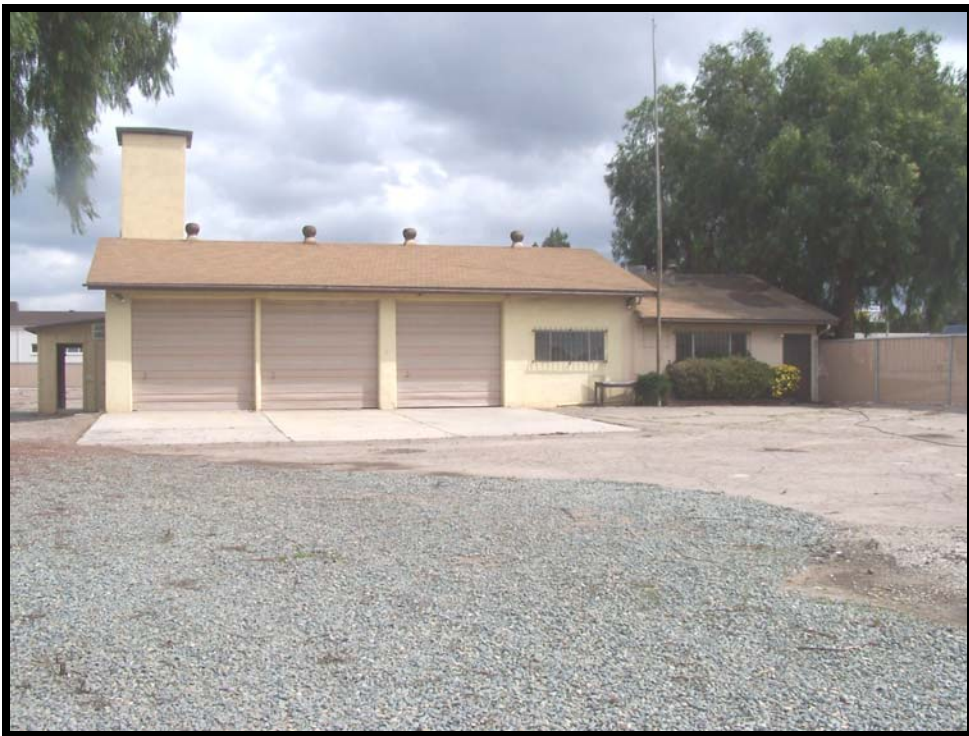
This single story rectangular fire station is a wood framed, stucco covered building set on a concrete slab foundation (Figures 4-5). The moderately pitched roof is covered with asphalt shingles. Three garage bays on the west side have roll-up garage doors. A hose-drying tower is located at the building's north east corner. Steel framed multi-pane windows are placed along the north and east sides. Aluminum sliding windows are situated at the south end of the west side. A solid single entry door is located on the west side at the building's south west corner.

Figure 4 Fire Station West Façade (Building B)

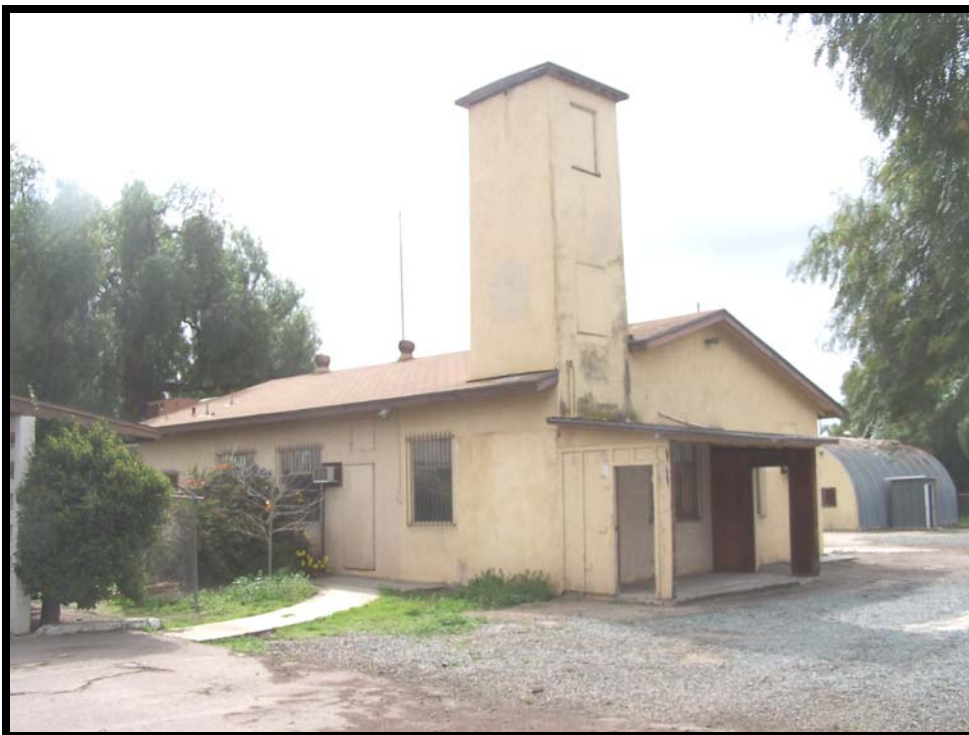
Figure 5 Fire Station, north and east facades (Building B)

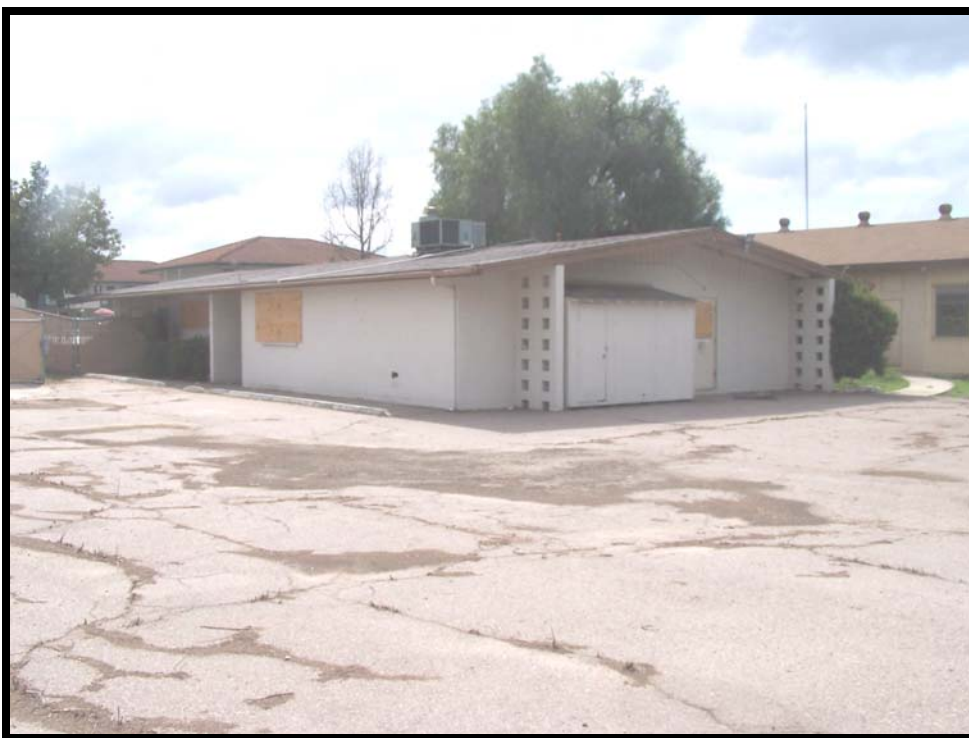
This single story rectangular building is constructed of concrete cinder block, and rests on a concrete slab foundation (Figure 6). The shallow pitched roof is covered with an asphalt shingle roof. The windows have been boarded up with plywood. A single entry door is centered on the north end. Others are irregularly placed along the east and west sides of the building.

Figure 6 Cinder block building, north and east facades (Building C)

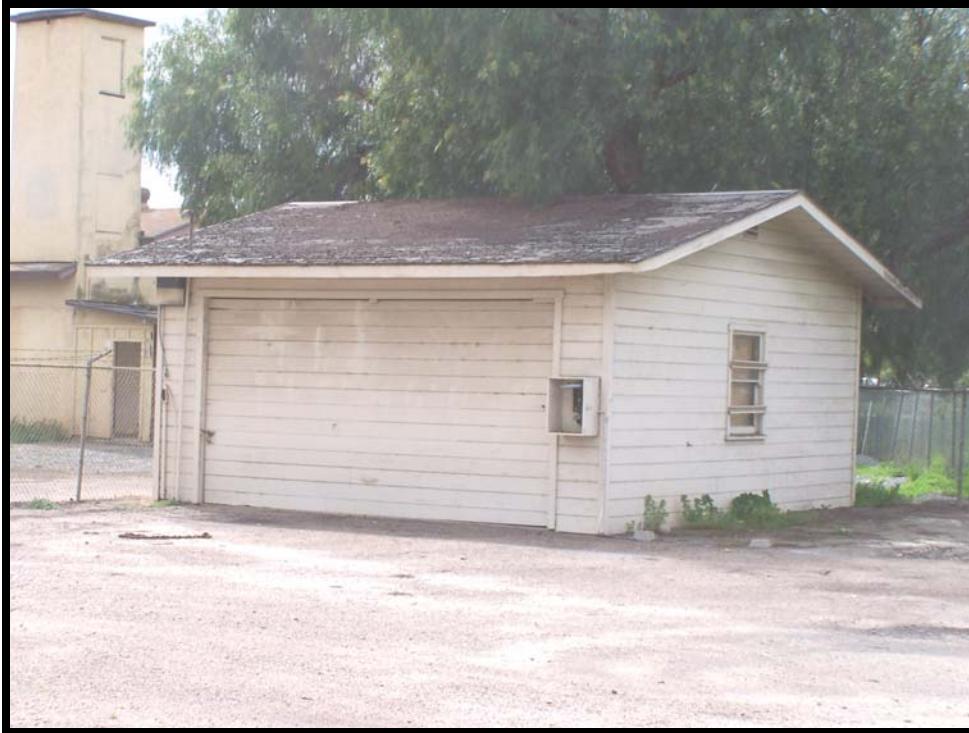
This single story rectangular wood framed building is constructed on a concrete slab (Figure 7). It is covered with horizontal wooden siding. Asphalt shingles cover the moderately pitched roof. A wooden garage door is centered on the east façade. A wood framed double hung sash window is centered on the north side.

Figure 7 North and east facades of wood framed garage (Building D)

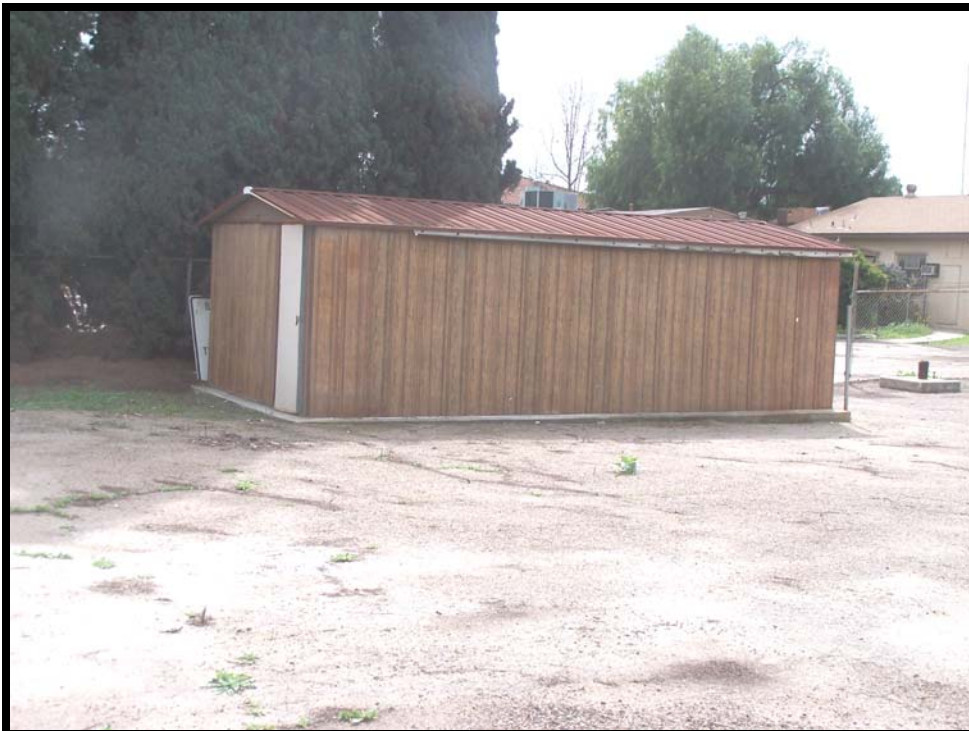
This prefabricated metal storage shed is approximately 20 feet long by 10 feet wide. It is erected on a poured concrete slab (Figure 8). It is the type of prefabricated metal shed available from many department stores, such as Sears, for example. It appears to be of recent construction.

Figure 8 Metal storage shed (Building E)
